## Introduction

This information sheet outlines reasonable owner expectations for an onsite sanded and finished timber floor. This includes solid T&G flooring, parquetry and other flooring types that have been sanded and finished onsite or recoated. Concerning this, there are performance aspects of the floor which generally relate to fixing integrity, board shape and movement, and then there are appearance aspects which focus more on the sanding and finishing.

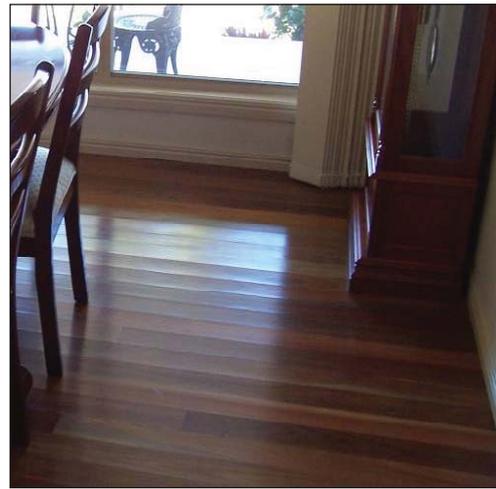
*Observable peaking*

**Peaking** – This has the appearance of cupping but is the result of expansion pressure in the floor. Again it is generally expected that a floor would be free of observable peaking.

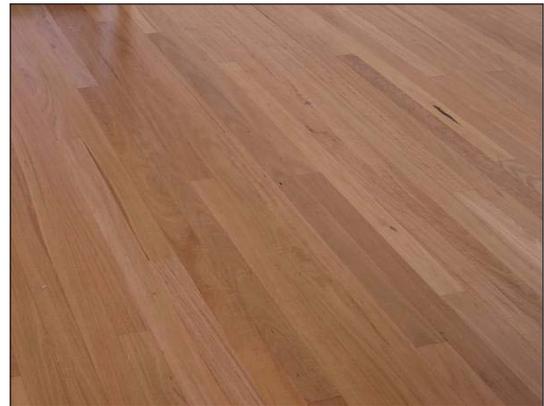
*A select grade Blackbutt floor where the backsawn gum vein toward the top right exceeds grade limits but is acceptable within the floor.*

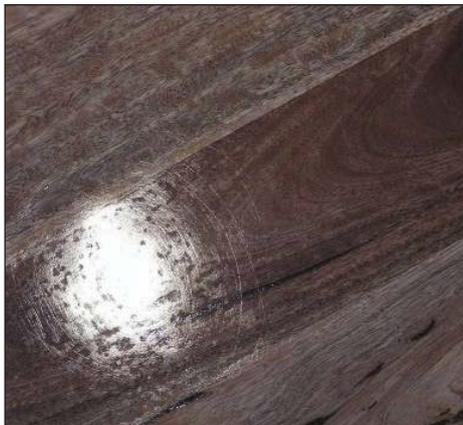
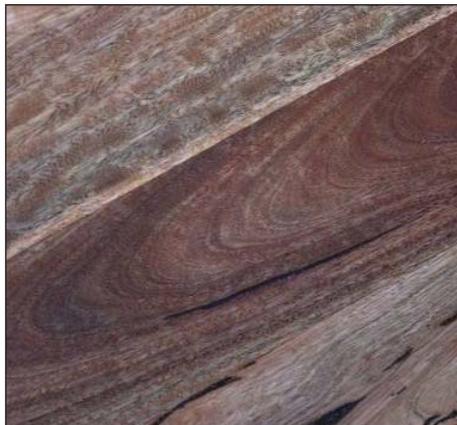
*The photo to the left shows circular swirl marks that are visible under down light. The photo to the right shows the same section of floor in natural light without the down lights on and the swirl marks are not visible.*

**Swirl marks** – Swirl marks are caused by rotary sanders and to some degree will be present in all floors. Down lights will highlight sanding imperfections due to light refraction through the coating and as such this is not controllable by the contractor. Fine swirl marks that are not obvious under natural light when assessing a floor should not be a concern.

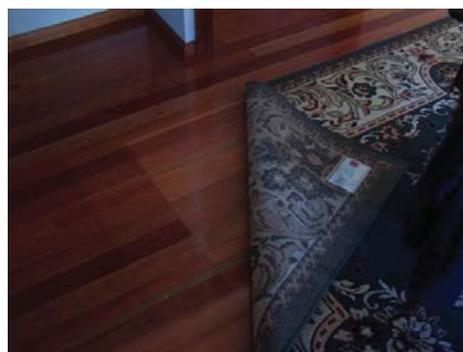
*Colour change of timber and coating beneath this floor rug.*

Over the course of time colour changes occur in timber floors from the effects of ultra violet light. Therefore it is usually more pronounced in sun exposed areas of the floor. This is partly associated with the changes in the timber and partly with the coating that is applied. Some coatings darken with time more than others and some timbers are more prone to colour changes than others. This process is natural and gradual but can result in distinct colour differences where rugs have been put on the floor. Some of this change can be minimised by not putting rugs down till six or so months after the floor has been completed. To avoid severe effects it is beneficial for flooring contractors to make clients aware of how the coating used may result in colour differences. From there it is up to the owner to manage how rugs are used.
